HOT PIPE COATING AT VANCOUVER SHIPYARDS

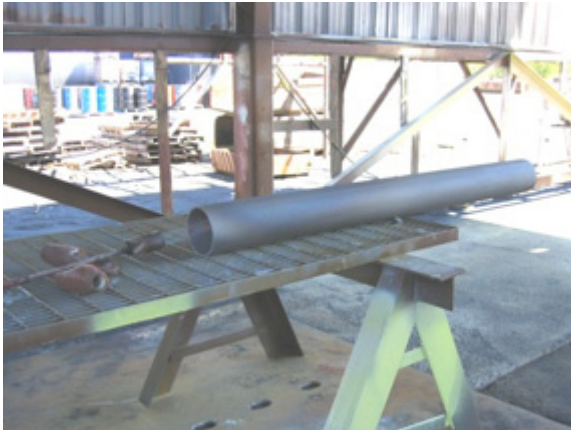
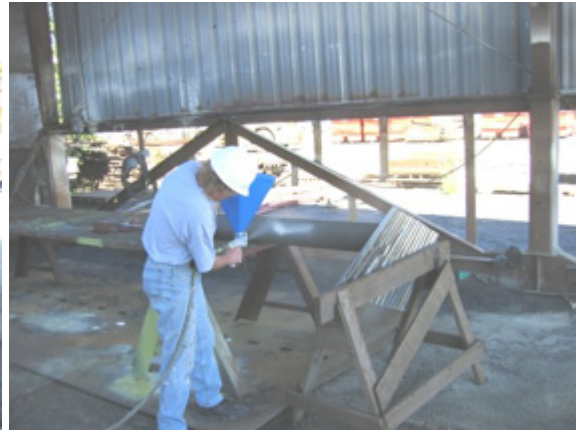
The video was taken after the second primer coat of approximately 50 mils (1.2mm) DFT and before it had finished steaming off to complete its cure down. This video is courtesy of Doug Robinson, the Health and Safety Officer at Vancouver Shipyards.

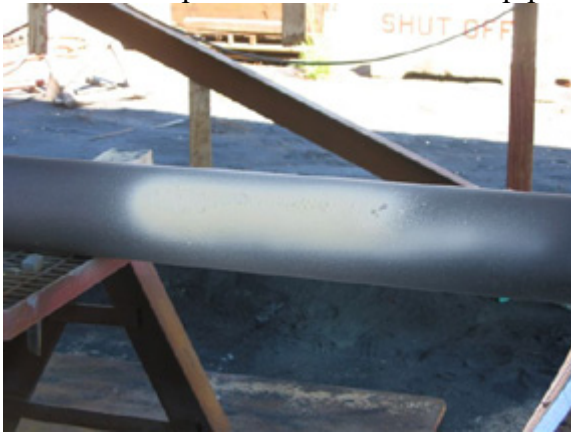
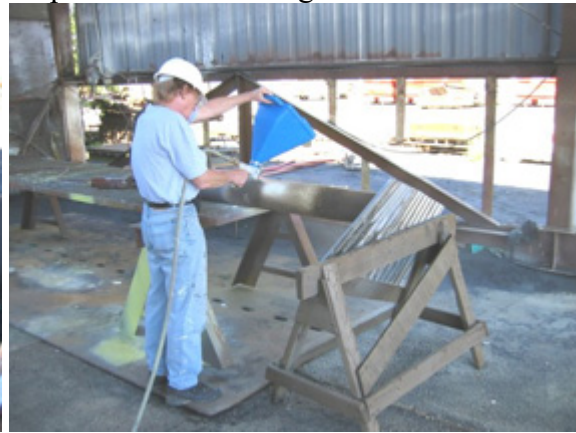
A piece of 8 " Schedule 40 pipe was preheated with a Tiger Torch.

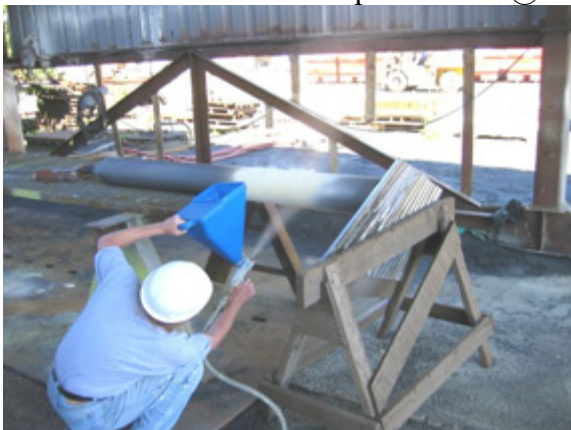
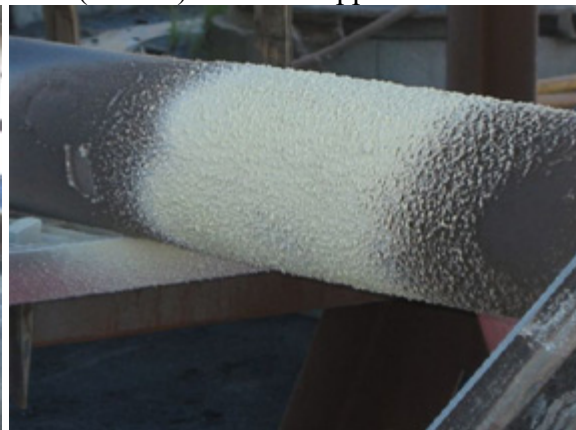
A temperature reduction from **350C** on the bare pipe to **170C** after the initial primer coat @ 50 mils (1.2mm) DFT was applied.

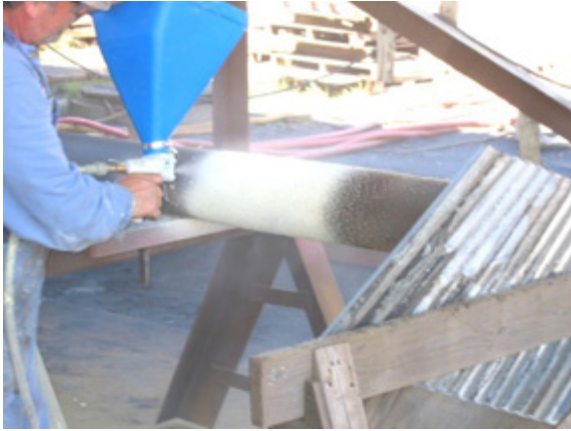
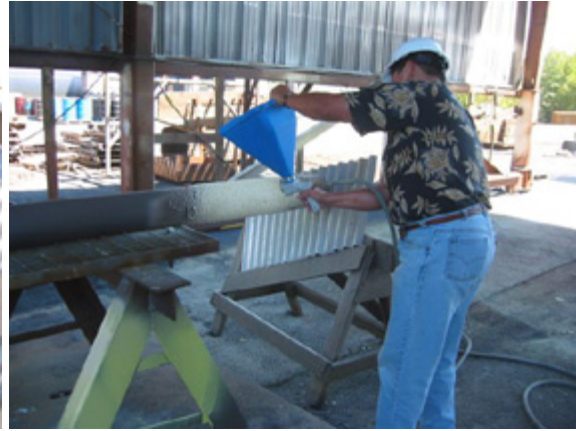
A temperature reduction from **370C** on the bare pipe to **90C** after the second primer coat @ 50 mils (1.2mm) DFT was applied. (Video)

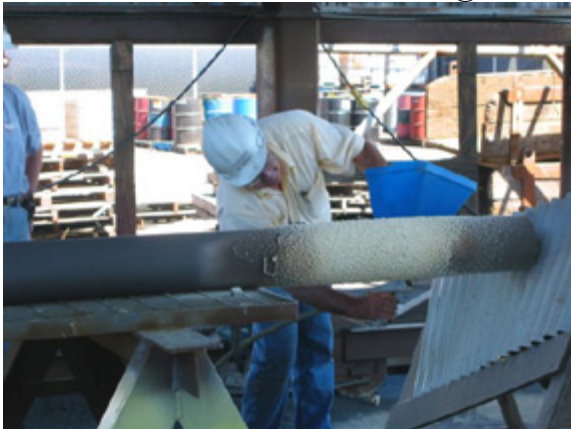
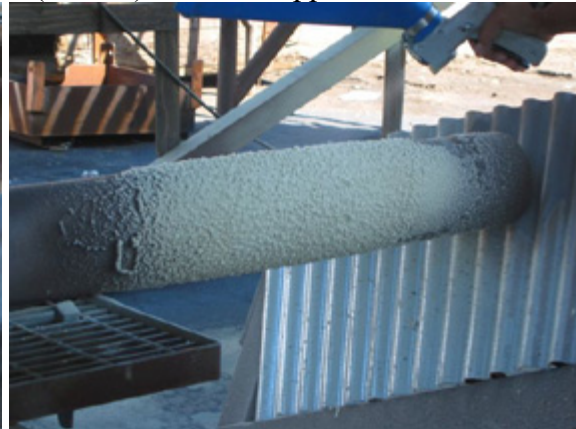
A temperature reduction from **395C** on the bare pipe to **55C** after the build coat @ 100 mils (2.5mm) DFT was applied.

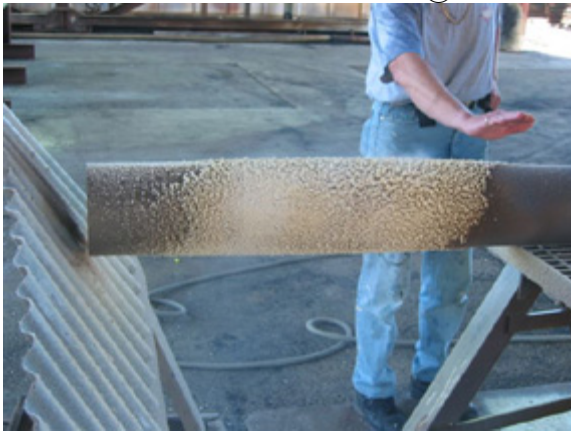
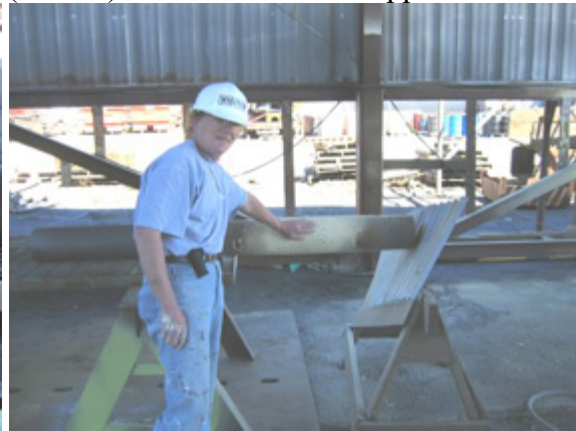
A temperature reduction from **400C** on the bare pipe to **50C** after the final build coat @ 250 mils (6.3mm) DFT **TOTAL** was applied.
